Mosquito Survey Alice Springs 4-5 September 2006

MEB Branch Report

Mosquito survey Alice Springs 4-5 September 2006

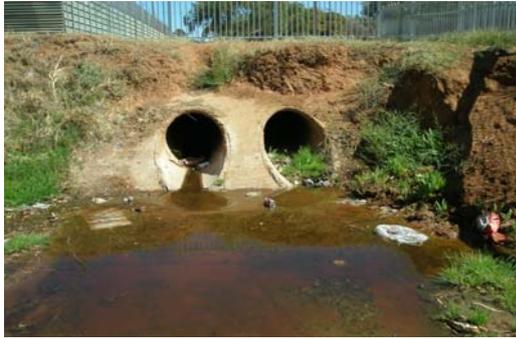
On 5th sep 2006 the MEB, Alice Springs EH and the Alice Springs Town Council inspected some of the Bloomfield drain site entry pits located close to the foot bridge opposite Milner Street (see Appendix 2). Relatively high numbers of *Culex quinquefasciatus* in this locality has been an issue in recent years, and the breeding source has not been previously located. Water was pooling at the end of the culvert and one of the pipes held water throughout its length under the footbridge. The second pipe was blocked by silt and most likely held water as well. Some rubbish was removed from the pipe and water containing mosquito larvae and pupae flowed out and pooled in front of the culvert.

The culvert opposite Milner Street holds water and mosquito breeding is frequently found (photo 1). The MEB is of the understanding that the drain pipe collapsed and is holding water opposite Lot 2907 (photo 2). The pipe needs to be fixed and the culverts desilted to ensure free flow of water. The concrete pad in front of the culvert needs to be lined up with the concrete invert of the Bloomfield drain to prevent water pooling (photo 1). Frequent mosquito breeding has been found in this drain. Thus, rectification of this drain should be made a priority.

Photo 1: Pipe outlet into Bloomfield St drain opposite Millner Rd.

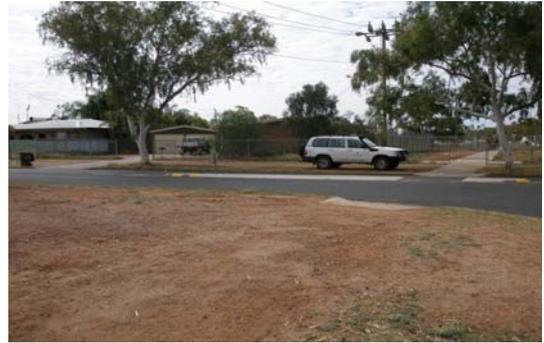
One of the site entry pits at the corner of Milner and Bloomfield Street also held water. The local Council staff member informed MEB that it has been previously determined that the drain pipe collapsed in front of Lot 2907 along Bloomfield Street and was holding water. It was agreed to recommend fixing of the drain pipe to prevent further mosquito breeding and to recommend that the culvert was connected to the concrete drain invert to ensure free water flow and prevent water from pooling in front of the culvert. It was further agreed to clean the Bloomfield Street drain again using the “super sucker”.

Photo 2: Site entry pit along Bloomfield St. Pipe collapsed and holding water in front of Lot 2907.

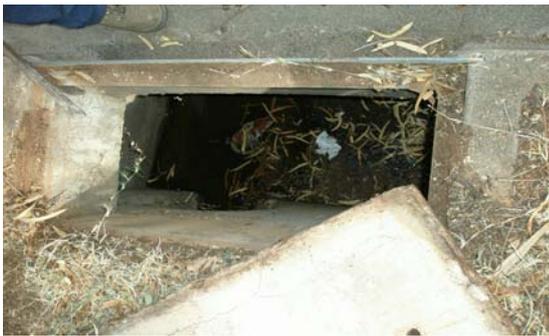
Photo 3: Site entry pit holding water on corner of Bloomfield St and Milner Rd.

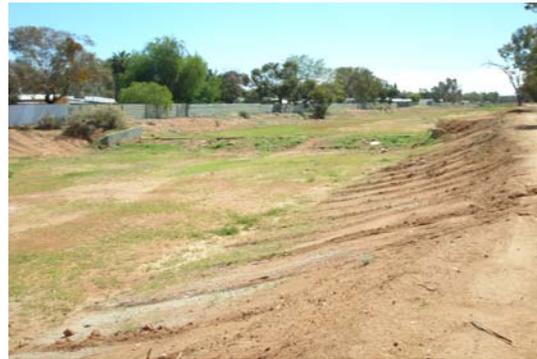
Photo 4: Bloomfield St drain. Filled in drop structure.

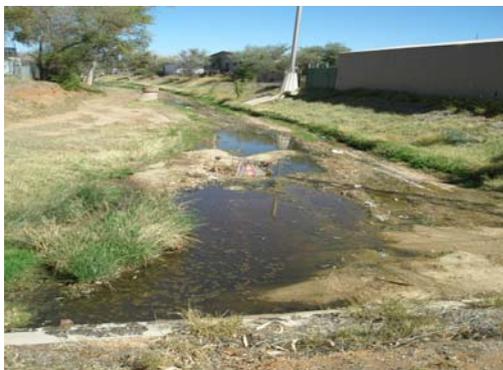
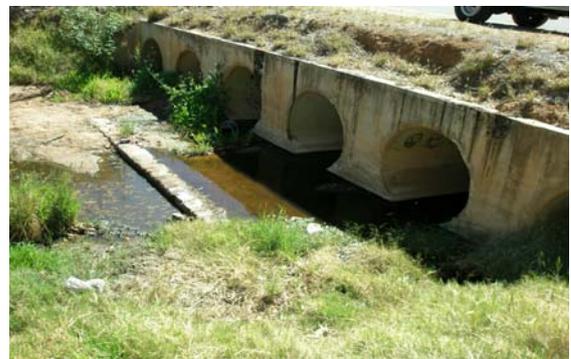
Photo 5: Brown St drain.

Photo 6: Brown St drain drop structure.

The drain needs to be re-levelled to ensure free flow of water out of the culvert and along the drain (photos 5 & 6).

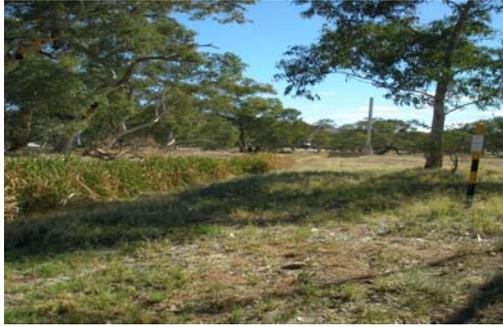
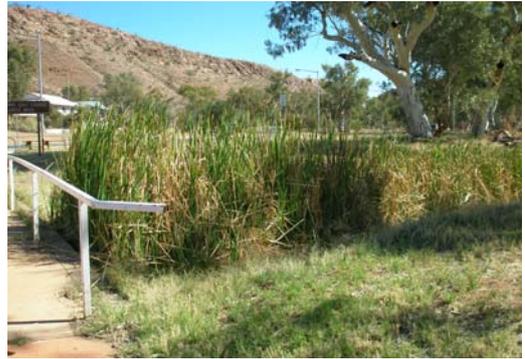
On 5th September 2006 the Casino drain was inspected. The drain was overgrown with Typha reeds (bullrush) and holding water. Part of the drain, between the bridge and the Casino is owned by the Casino, while the other half is under DIPE responsibility. It was agreed to recommend to DIPE and the Casino manager for weediciding and removal of the Typha reeds, as well as lining the drain with a concrete invert, as a long term solution to ensure water flow.

Photo 7: Casino drain, overgrown with Typha and holding water.

Photo 8: Casino drain, overgrown with Typha and holding water.

The part of the Casino drain under DIPE responsibility needs to be cleared of typha reeds and other vegetation (photos 7 & 8). It is recommended to weedicide the typha reeds twice within two weeks, with the weedicide mentioned above, before cleaning out the drain. The casino manager will be notified to maintain their part of the drain. A concrete invert is also recommended as a long term solution for this drain to ensure free flow of water.

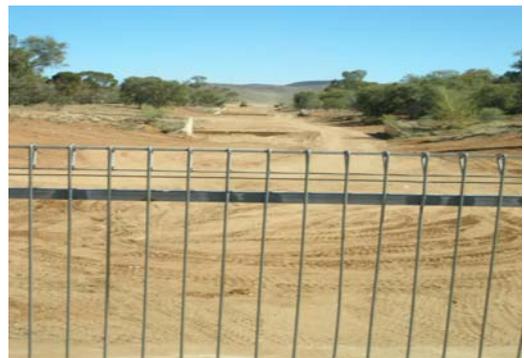
Photo 10: Ellery St drain, maintenance works carried out in Sep 06.

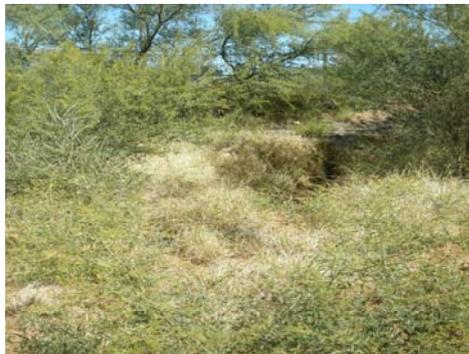
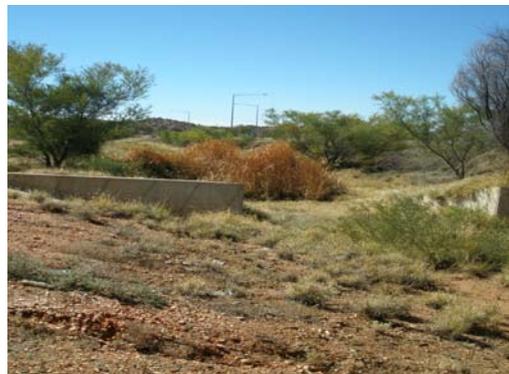
Photo 11: Larapinta drain.

Photo 12: Larapinta drain.

The vegetation needs to be removed and levels of the drain re-contoured to ensure free flow of water. Concrete lining of the drain needs to be considered and a concrete invert is recommended to prevent water from sitting in the pipe (photo 11 & 12).

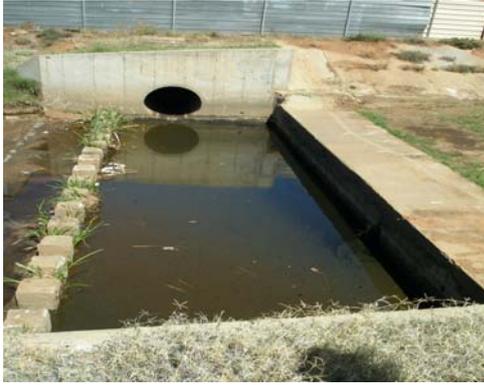
Photo 13: Railway Yard drain, drop structure holding water.

The drop structure opposite the railway yards is holding water (photo 13). As the water seems to pool in the drop structure only, it is recommended to treat this area with methoprene briquettes to prevent mosquito breeding.

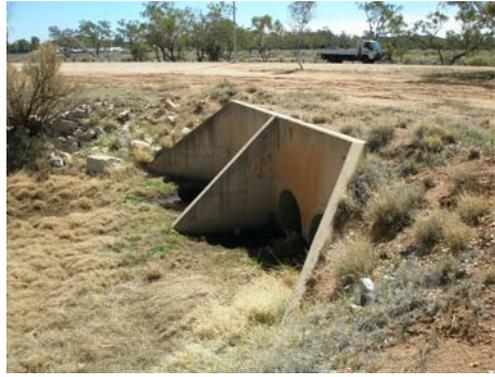
Photo 14: Sadadeen drain. Culvert holding water.

The vegetation needs to be removed and the drop structure to be filled to prevent water pooling (photo 15). The whole drain between the culvert (including the culvert) (photo 14) and the Todd River needs to be re-levelled to allow water to flow freely. After re-levelling the drain needs to be maintained and desilted on an annual basis. Rectification and annual maintenance of this drain should be made a priority.

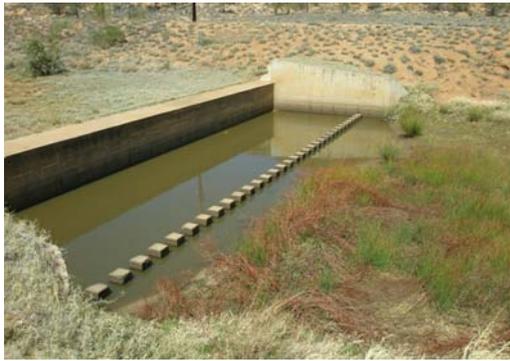
Photo 15: Sadadeen drain. Drop structure holding water.

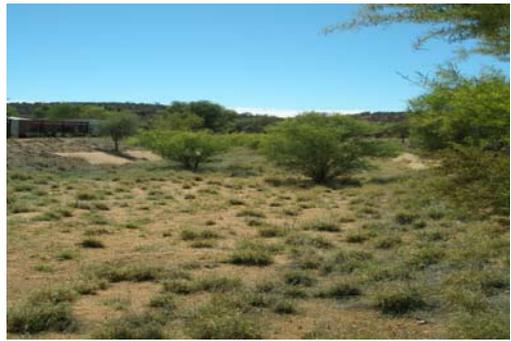
Photo 16: Undoolya St drain.

The vegetation needs to be removed (photo 16) and the drop structure to be filled to prevent water pooling (photo 17).

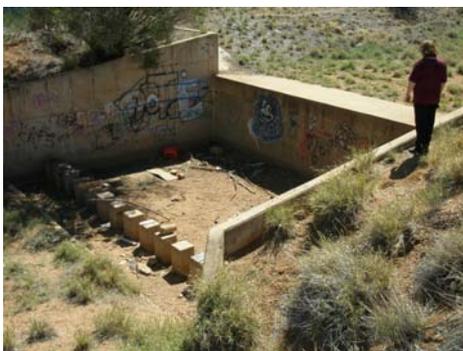
Photo 17: Undoolya St drain drop structure.

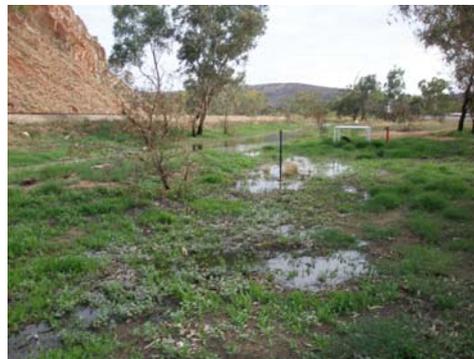
Photo 18: Drainage area between OUD under Ilparpa Rd and St Mary's Creek.

The area the OUD drains into between Ilparpa Rd and St Mary's Creek needs to be cleared of vegetation to ensure free flow of water into St Mary's Creek (photo 18).

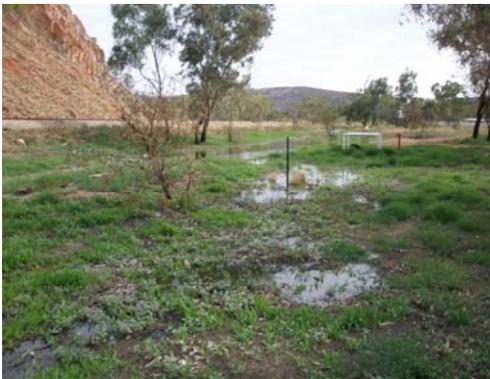
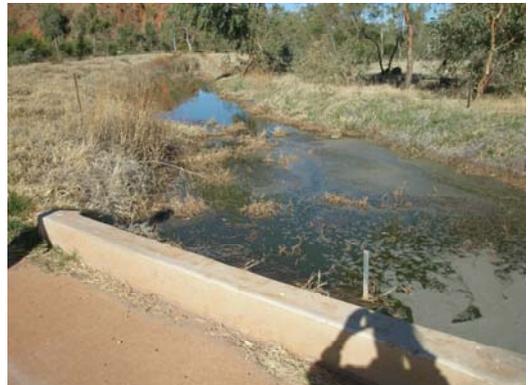
The finger drains and the Ilparpa swamp main outlet drain were found in good condition. However, the OUD south of Ilparpa Road, leading into St Mary's Creek requires maintenance work (vegetation clearing) to ensure free water flow (see Appendix 2).

Photo 23: Ilparpa swamp, OUD leading into St Mary's Creek, south of Ilparpa Rd.

Photo 24: Ilparpa swamp, OUD south of Ilparpa Rd.

The Ilparpa swamp was mostly dry at the time of visit. However, overnight temperatures are starting to increase and no further discharge is recommended from the sewage ponds into Ilparpa swamp to prevent mosquito breeding. Excess effluent should be dispersed by sprinklers and other methods that do not lead to surface ponding. Any discharge into Ilparpa swamp should only be out of EP7 (ponds A), as the effluent will be drained out of the swamp through channels into St Marys Creek. It is recommended to dispose of as much effluent as possible through managed sprinkling during the summer months. Maintenance of the OUD south of Ilparpa Road is recommended to prevent water pooling and subsequent mosquito breeding.

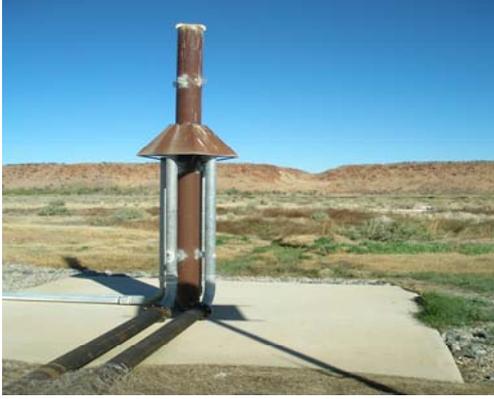
The MEB was advised that the plantation sprinklers east of ponds B were not in use any longer due to high maintenance issues, but discharge into the plantation was still carried out. At EP10 the “rocket” (dispersal machinery, see Appendix 2) was used to disperse treated effluent into Ilparpa swamp. To reduce pond levels, treated effluent is also dispersed by sprinklers at Blatherskite Park.

Photo 25: Ilparpa swamp, effluent dispersal at EP 10 overflow.
